Effects of bank vegetation in waterways with special reference to bank erosion, shear strength, root density and channel hydraulics

**Effects of Bank Vegetation in Waterways with Special
Reference to Bank Erosion, Shear Strength, Root Density and
Channel Hydraulics**

**A thesis submitted to the Open University
for the Degree of Doctor of Philosophy
Biology Department
September 1992**

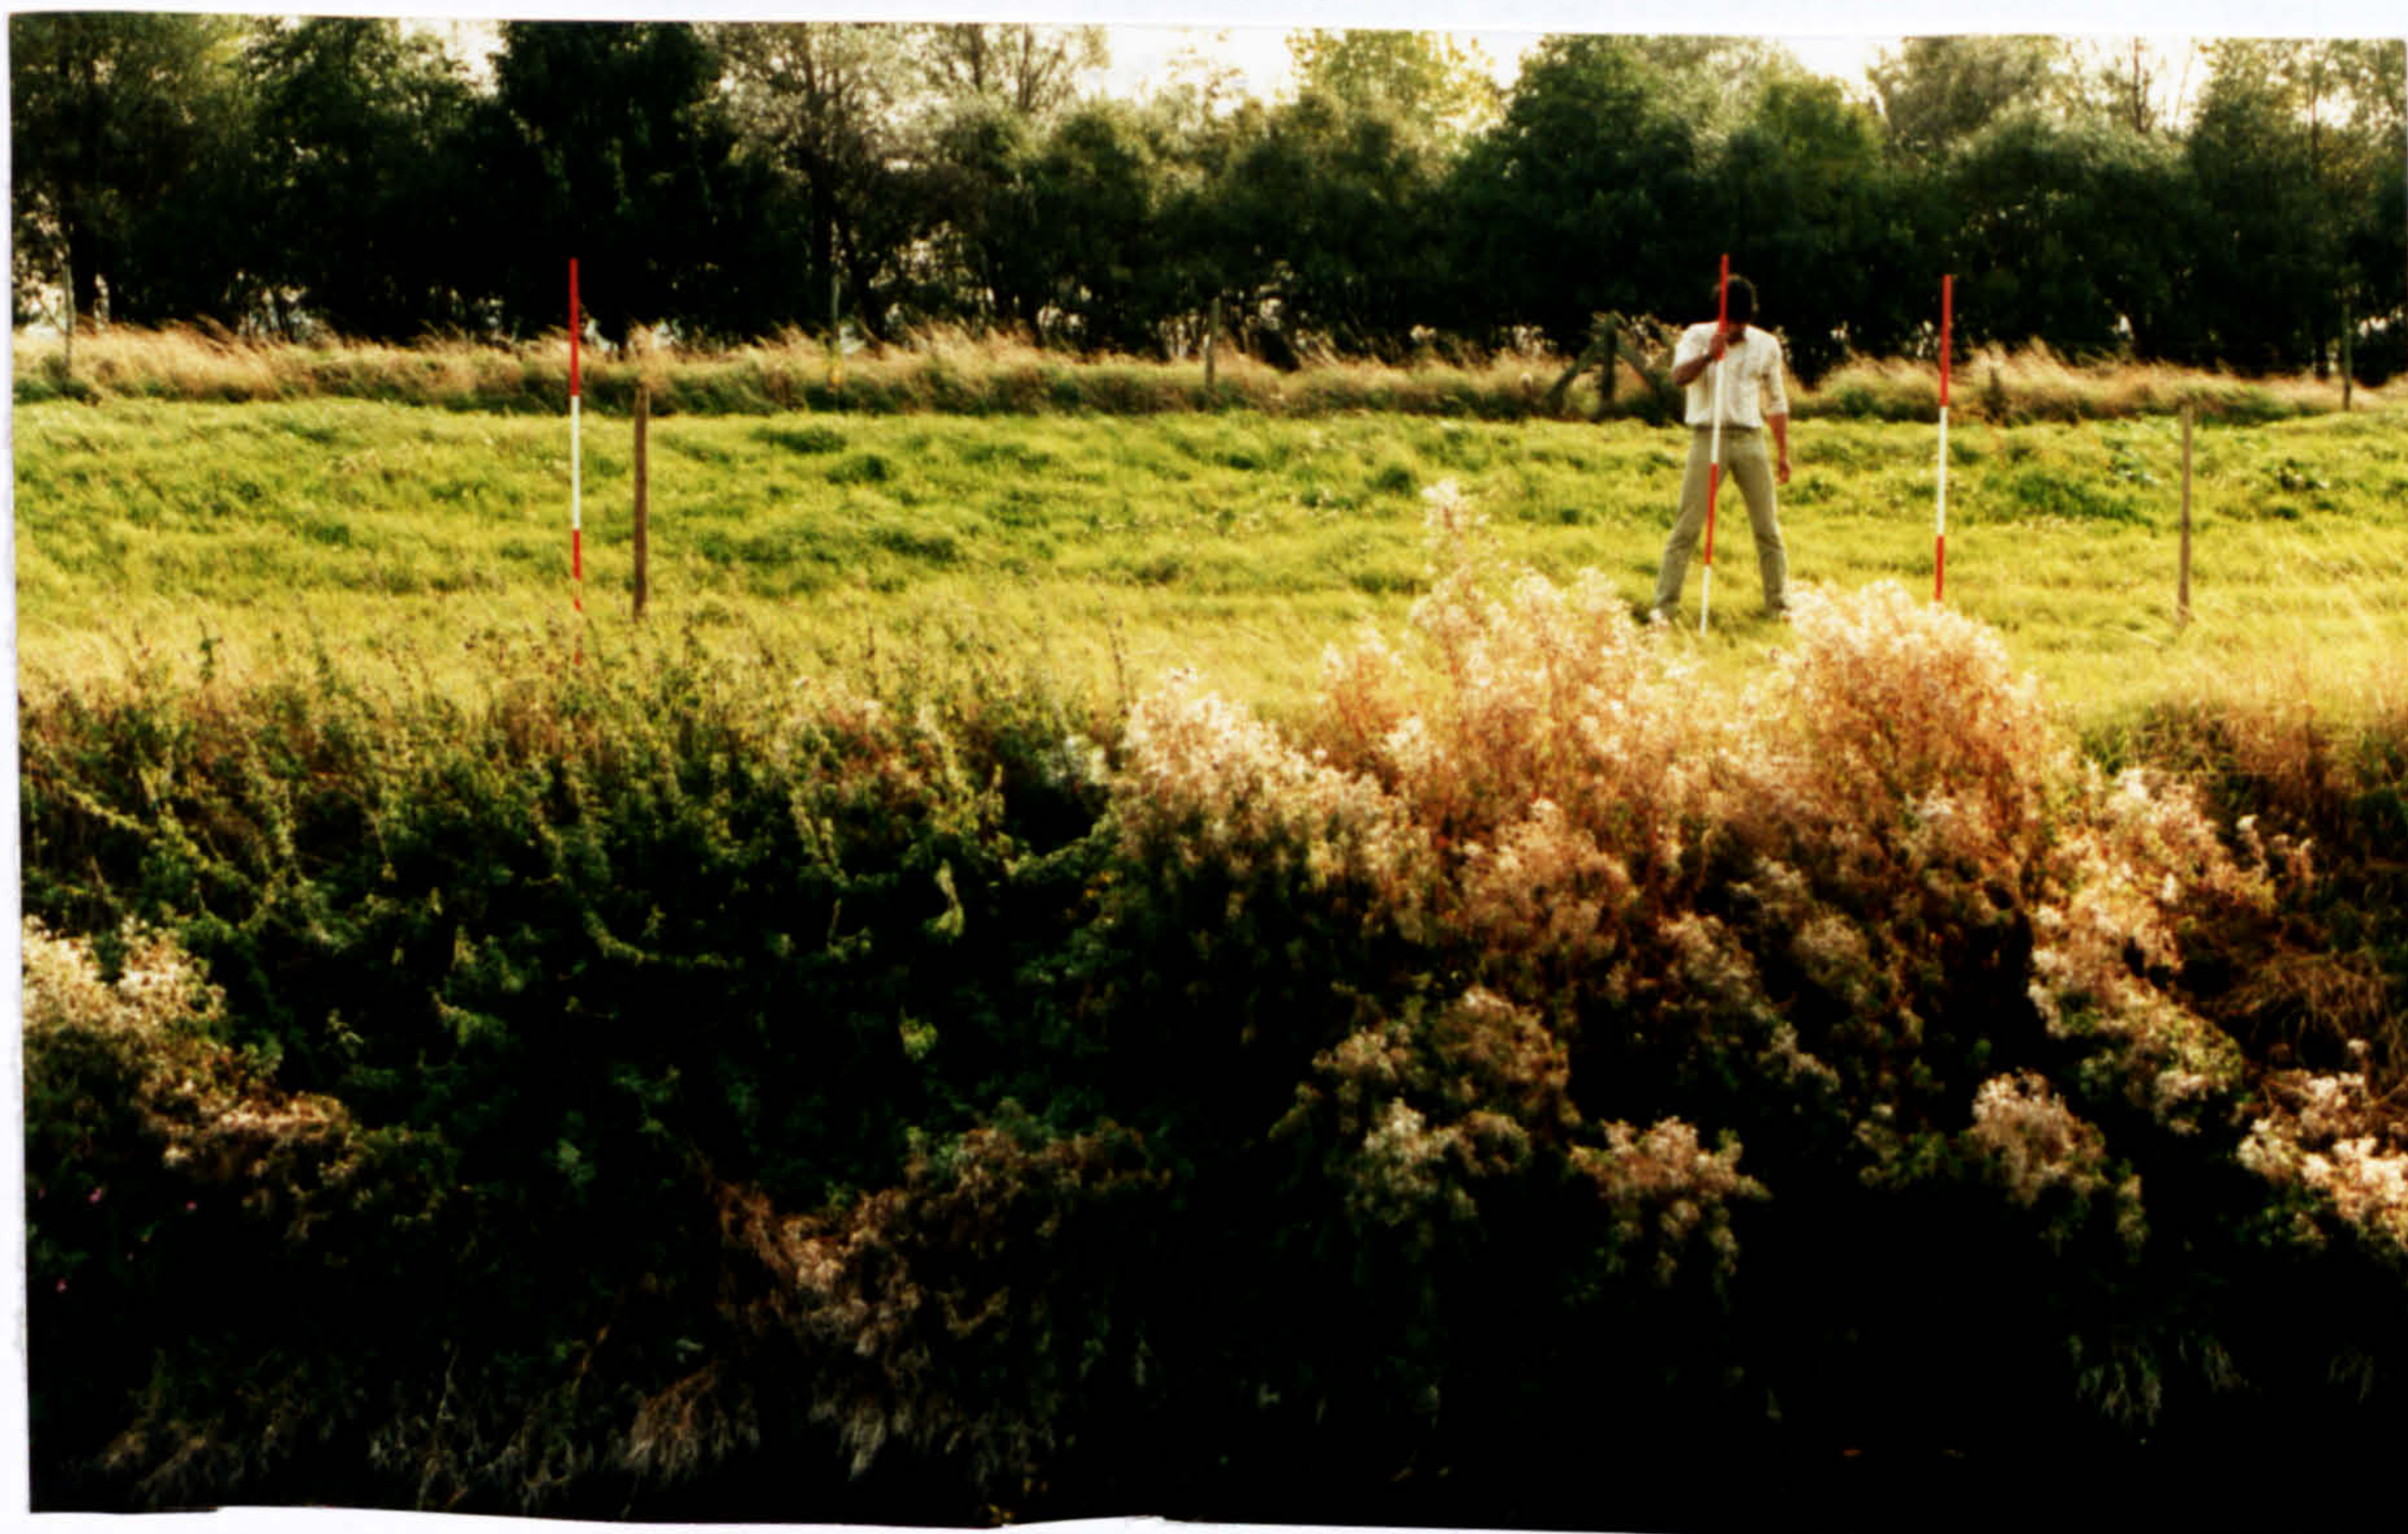
Plate 5. Natural vegetation dominated by *Epilobium hirsutum* (Plot 3a)
 N.B. Lack of fringe vegetation (at level 1) thereby exposing this area to undercutting

a) Phase 1 The effect of dead vegetation cover on the banks is reflected in the lower rates of erosion for the lower banks allocated for natural re-vegetation. Note the newly emergent vegetation at the bank toe-region in Plate 9. Compare this with the complete absence of such fringe vegetation in the long established natural vegetation in Plate 5.

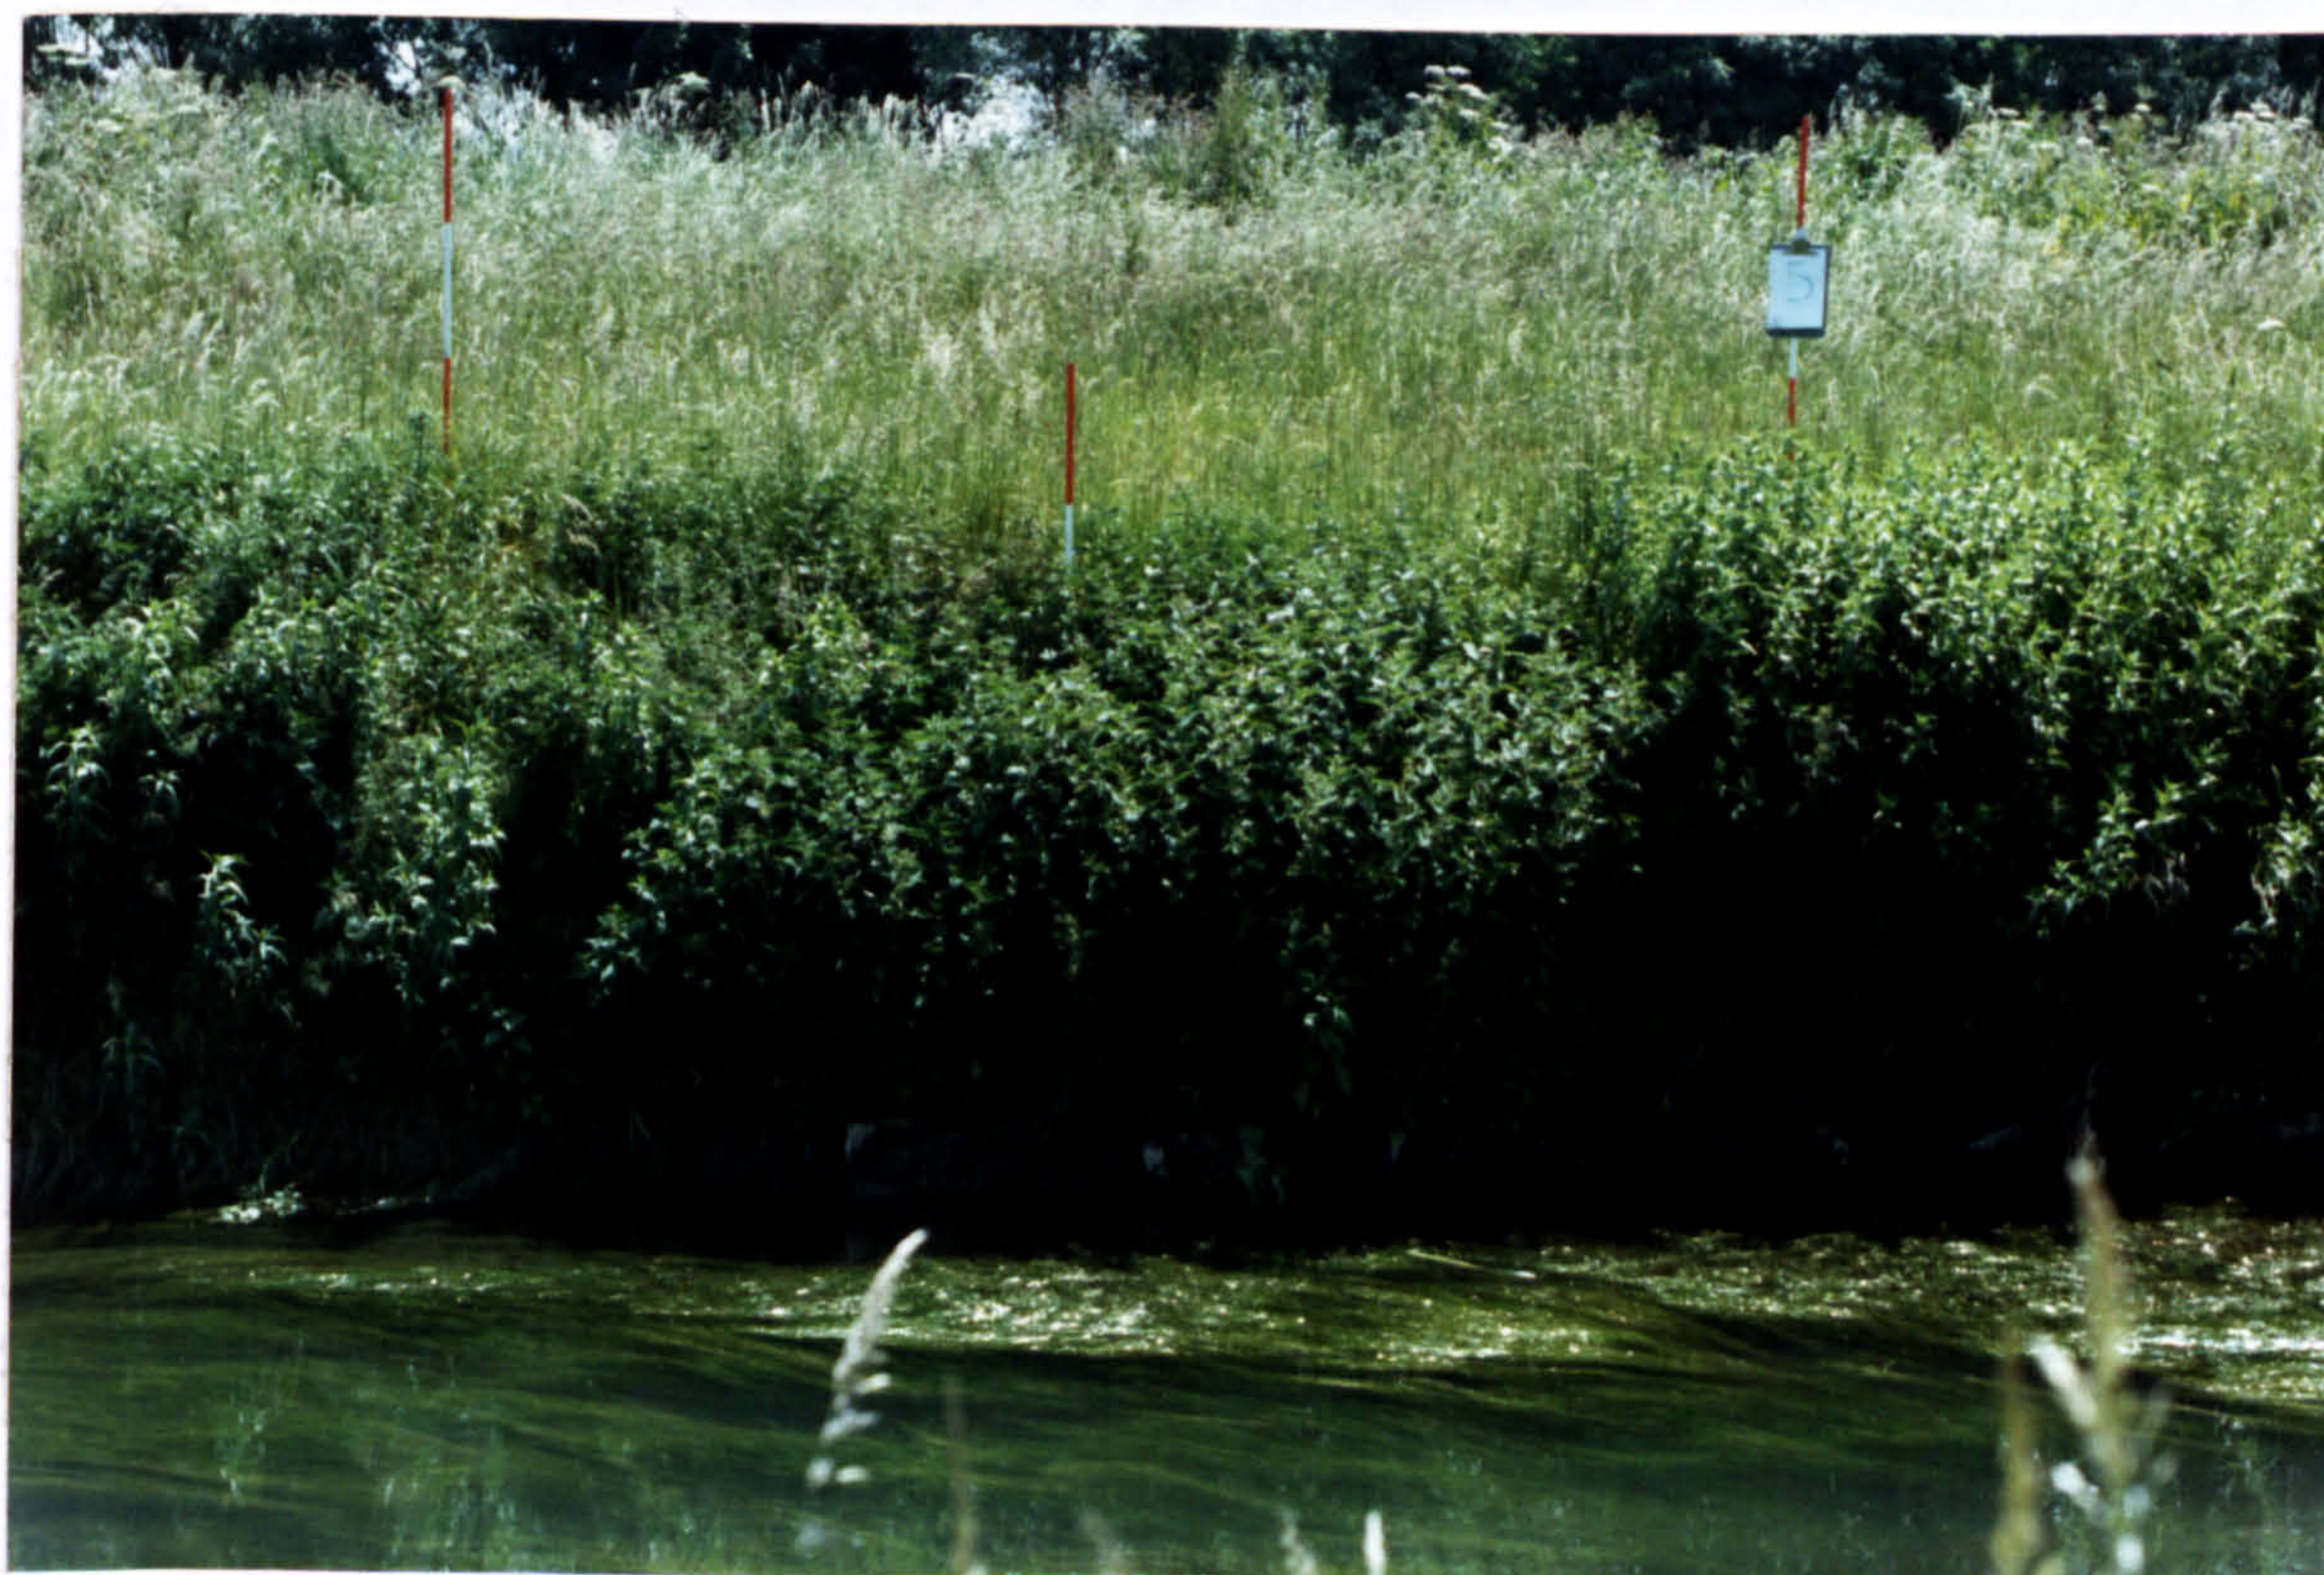
Plate 6. Natural vegetation dominated by *Urtica dioica* (Plot 5a)
 N.B. Lack of fringe vegetation (at level 1) thereby exposing this area to undercutting

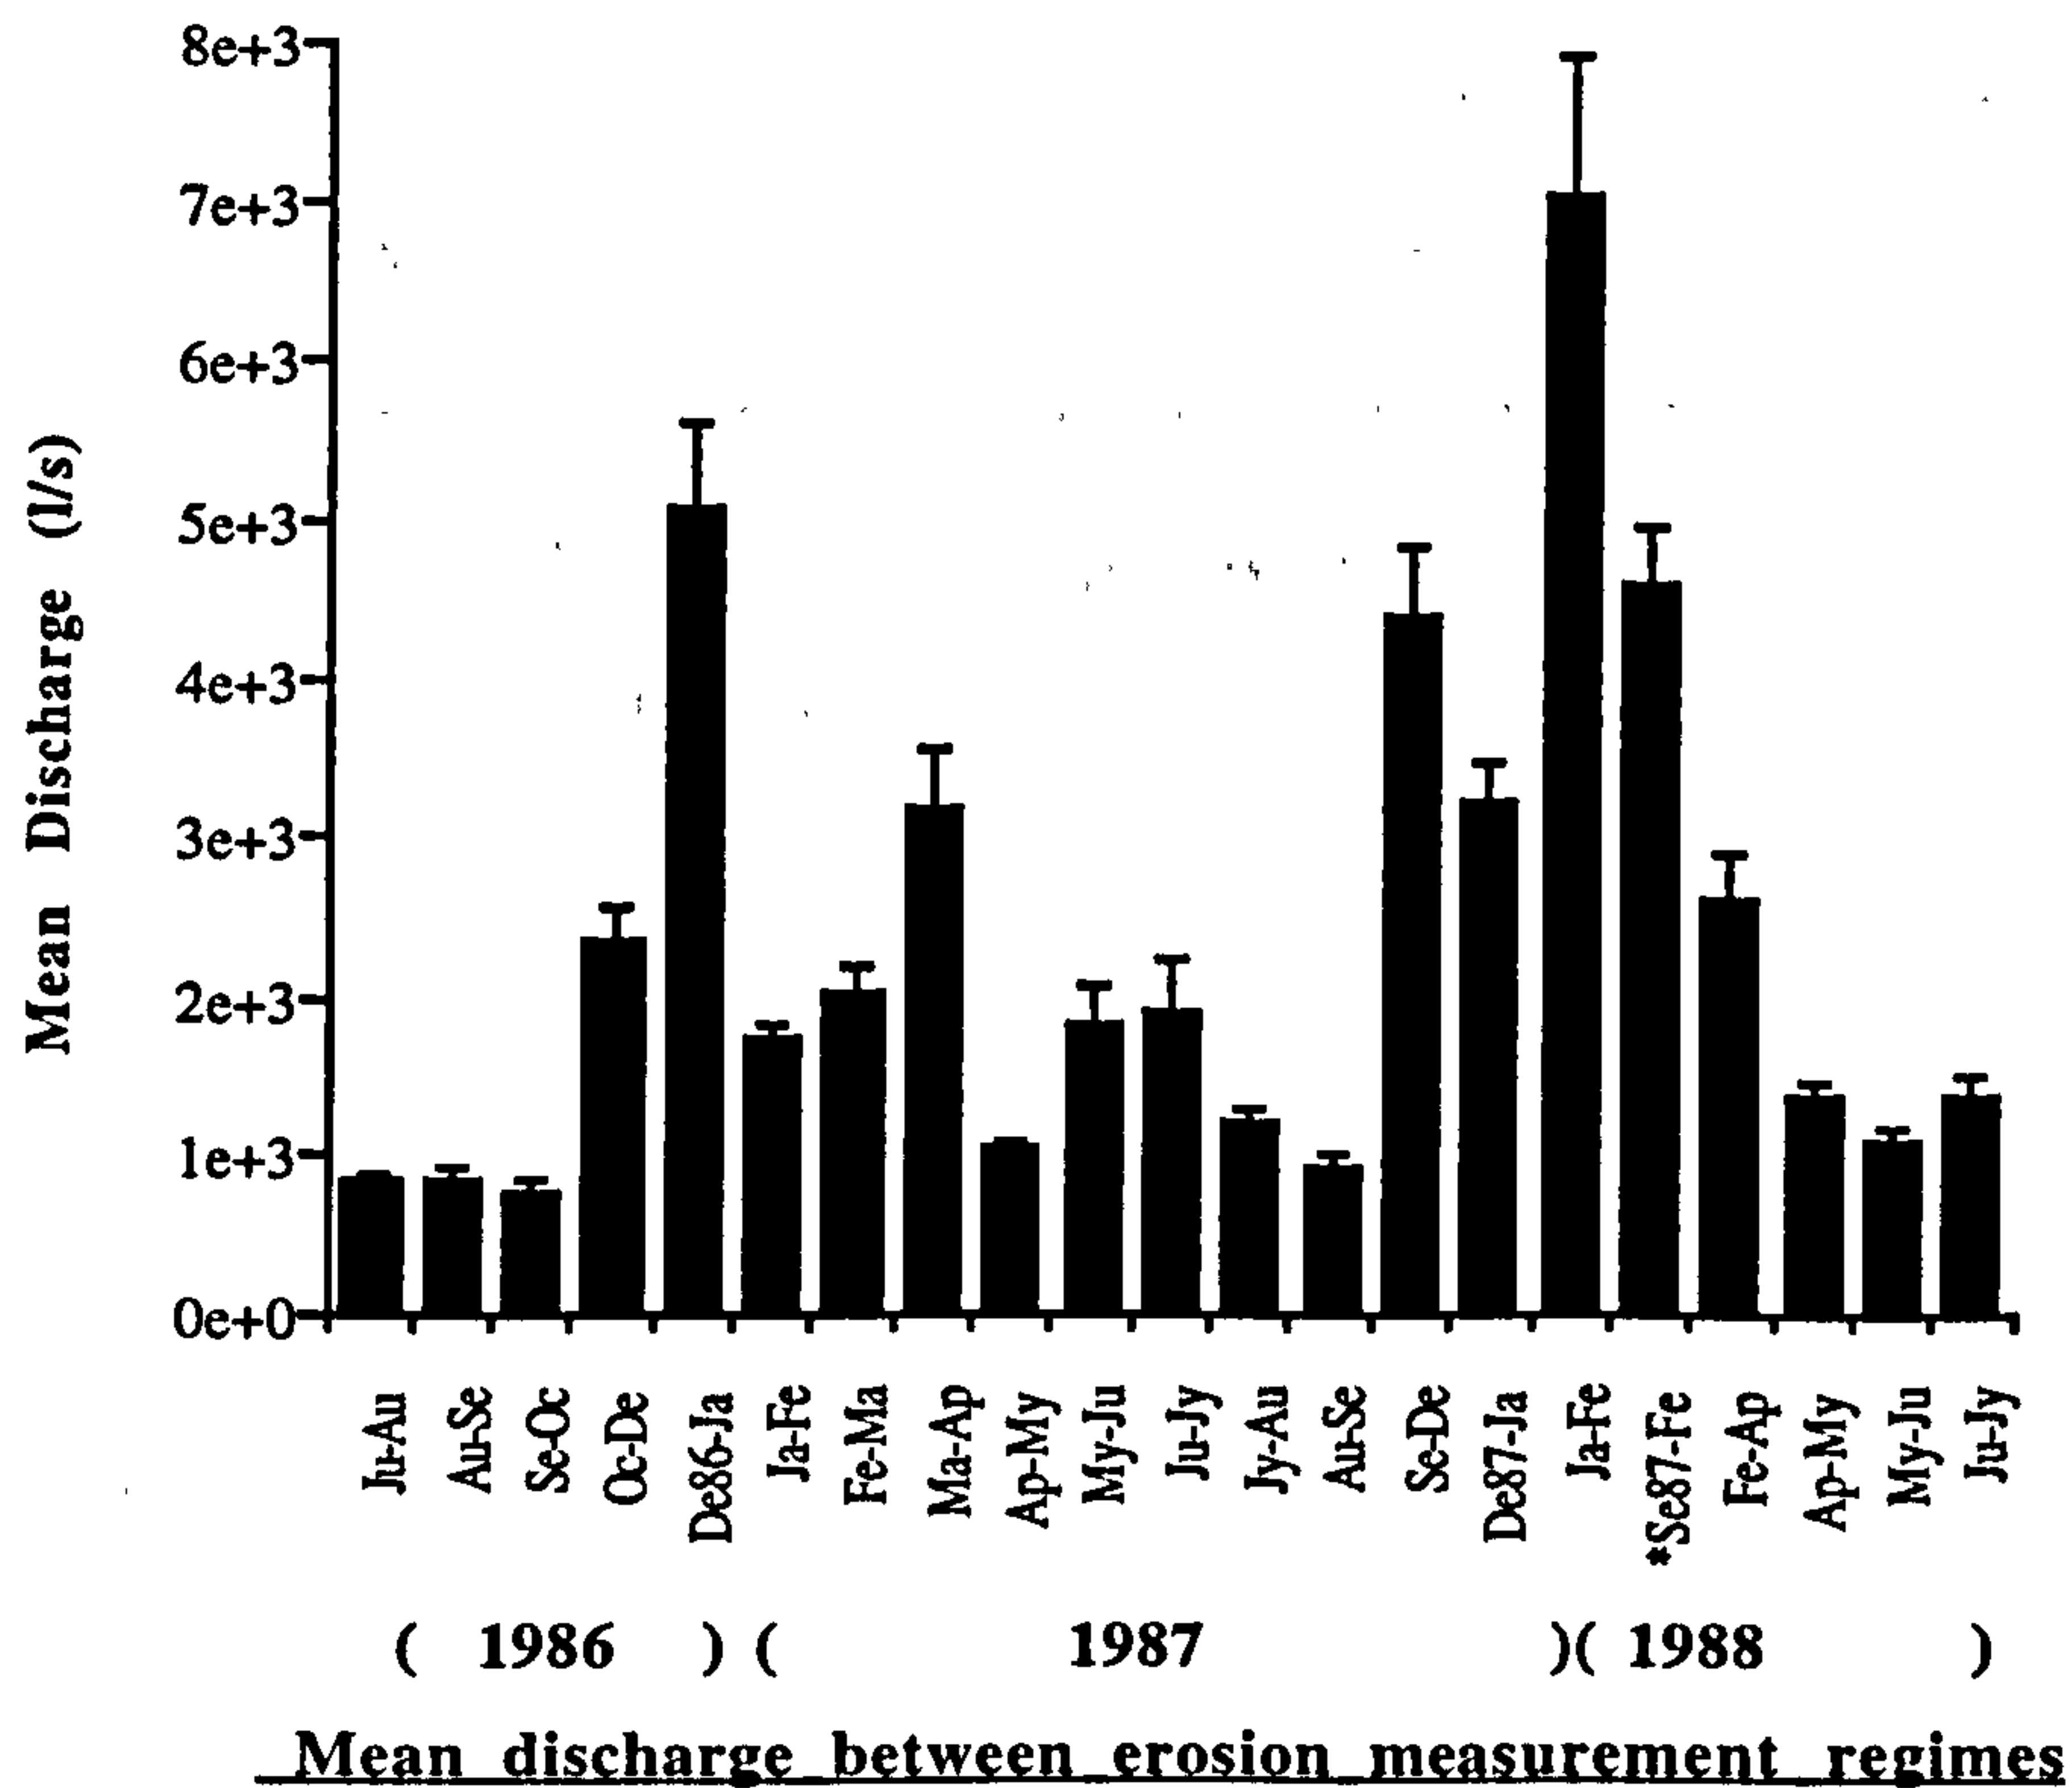
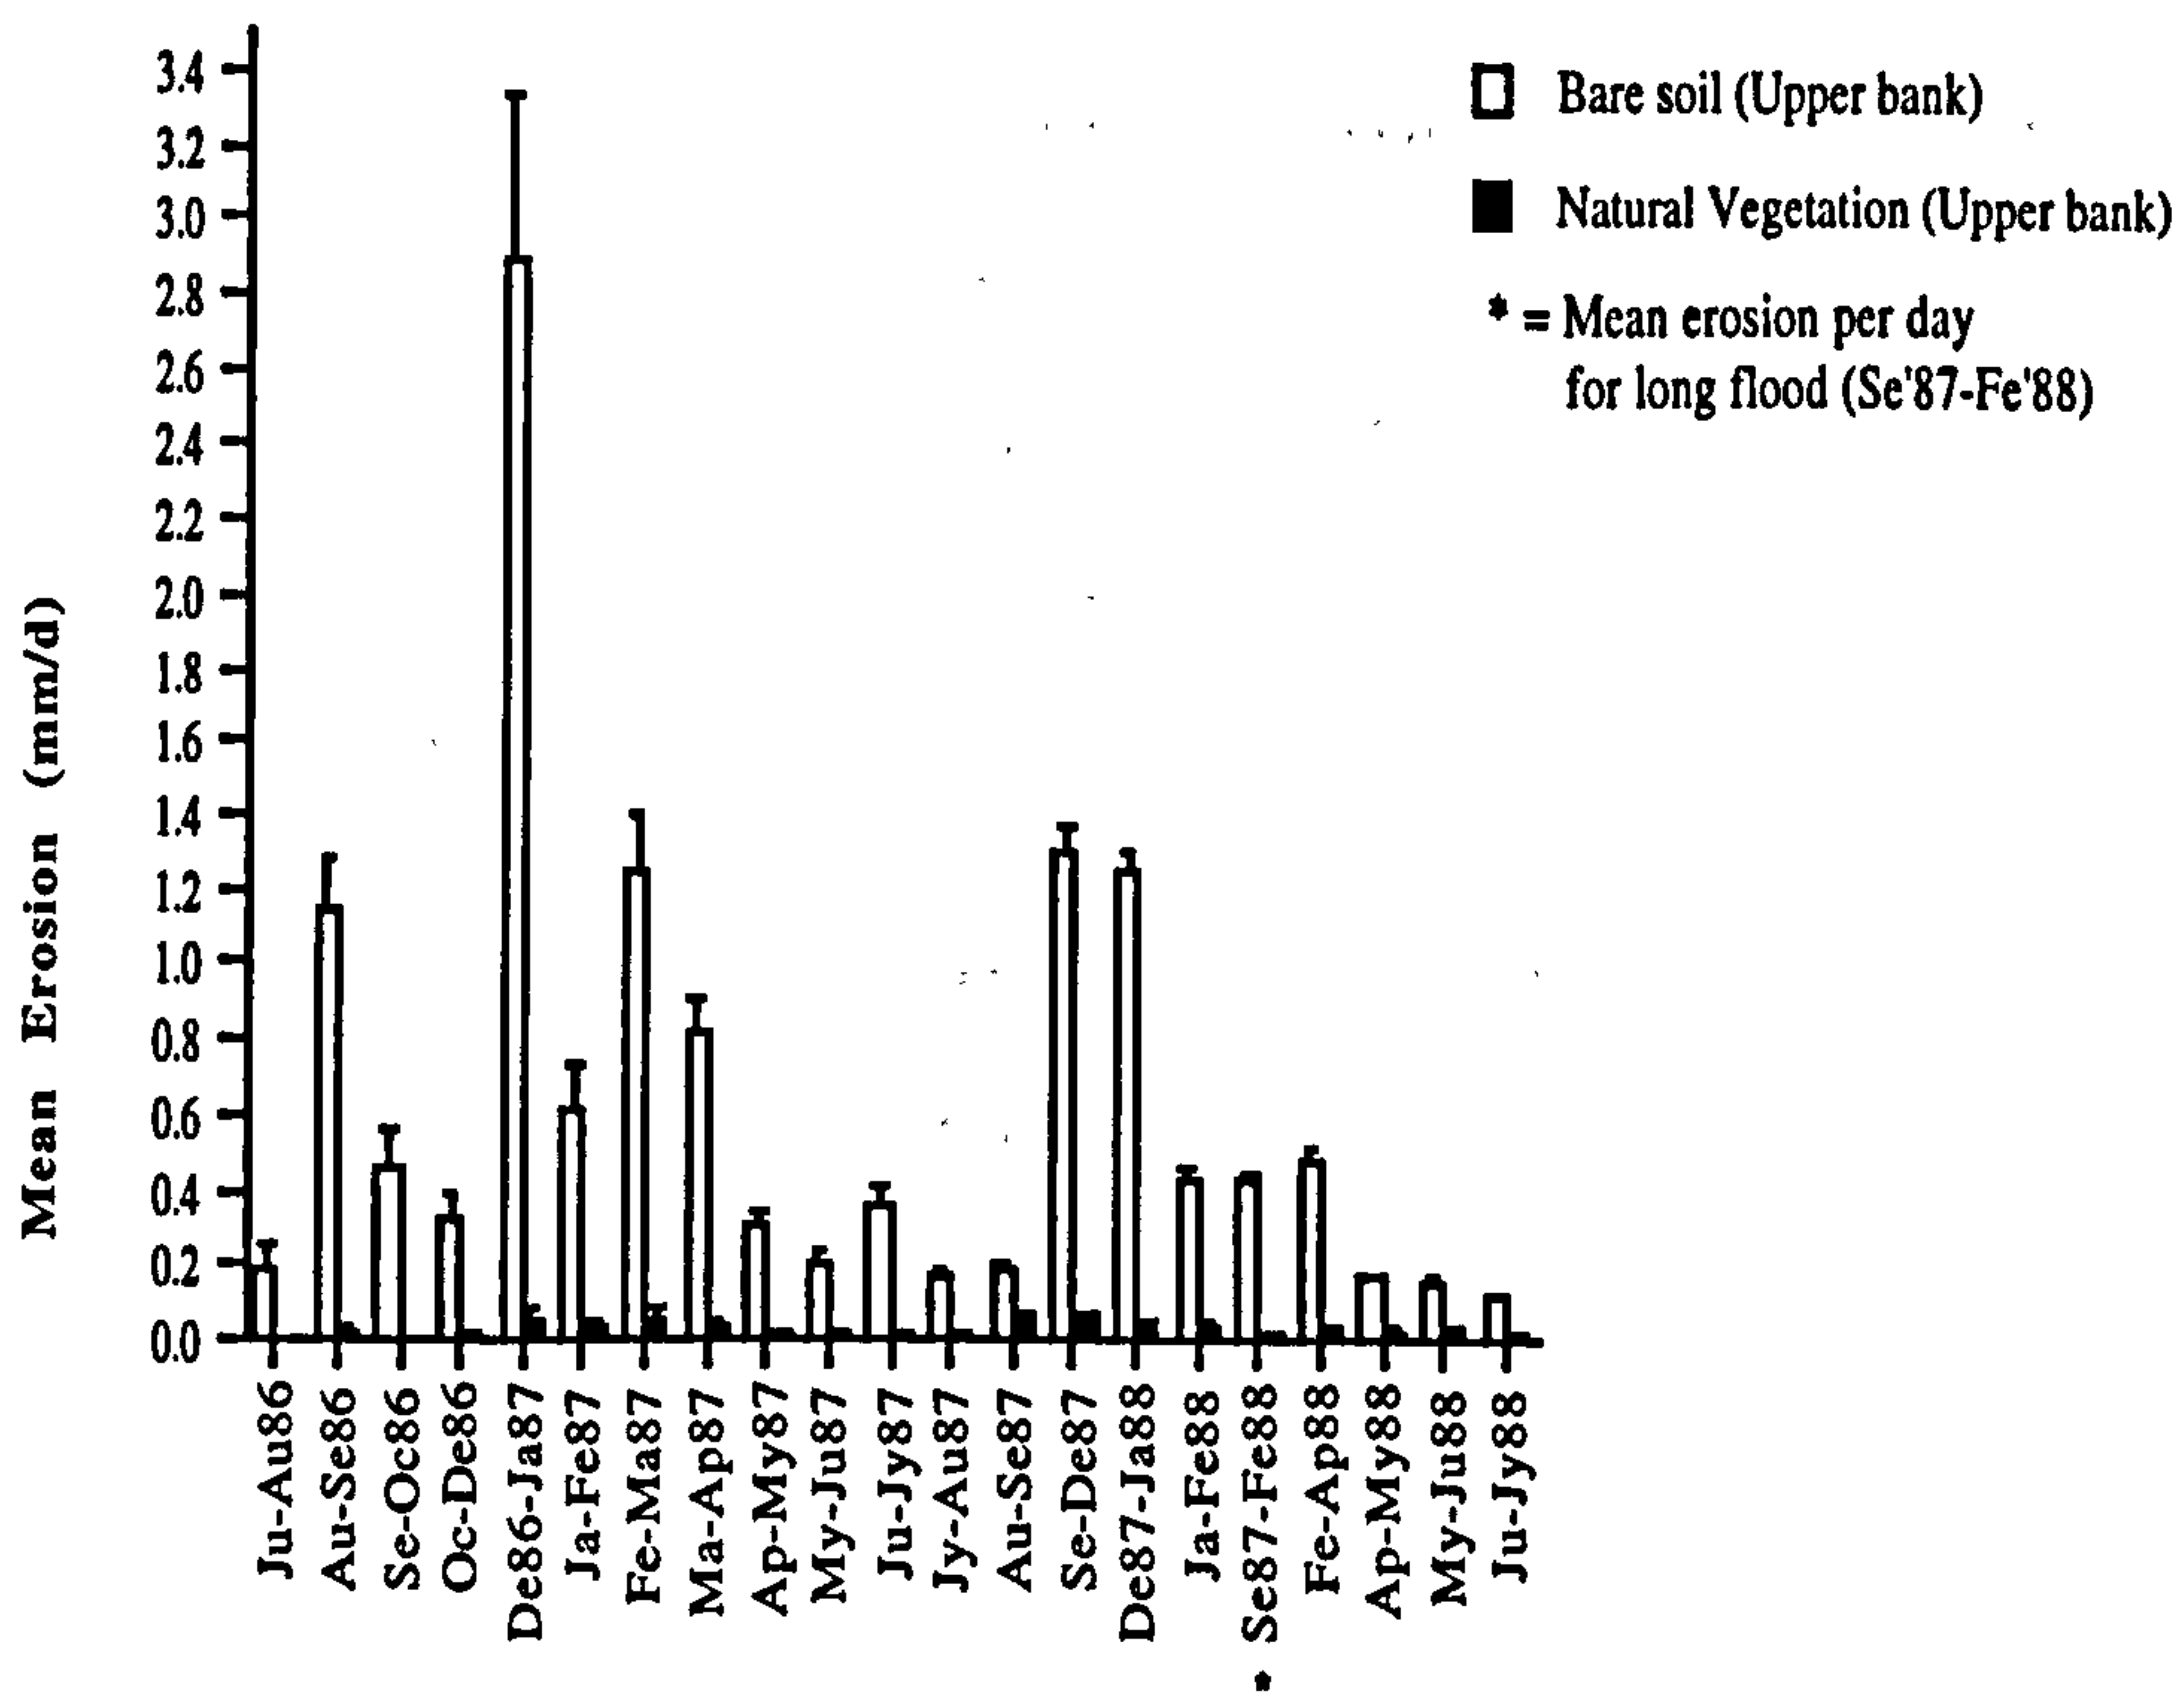
Fig. 3.4. : Comparison of erosion : Bare Vs. Natural vegetation; (Upper banks)

As shown in Fig.3.4 below, there is minimal if any, erosion for normally vegetated banks throughout.the experimental period. This includes periods of stormflow lasting for over three months. But the magnitude of erosion of the bare upper banks is highly significant. The level of significance in the comparison between the treatments is graphically obvious and at no period of erosion warrants a statistical analysis for confirmation. However as Table 1b shows, the flow correlation (both maximum and mean) with mean erosion is significant for both treatments in the upper bank region.

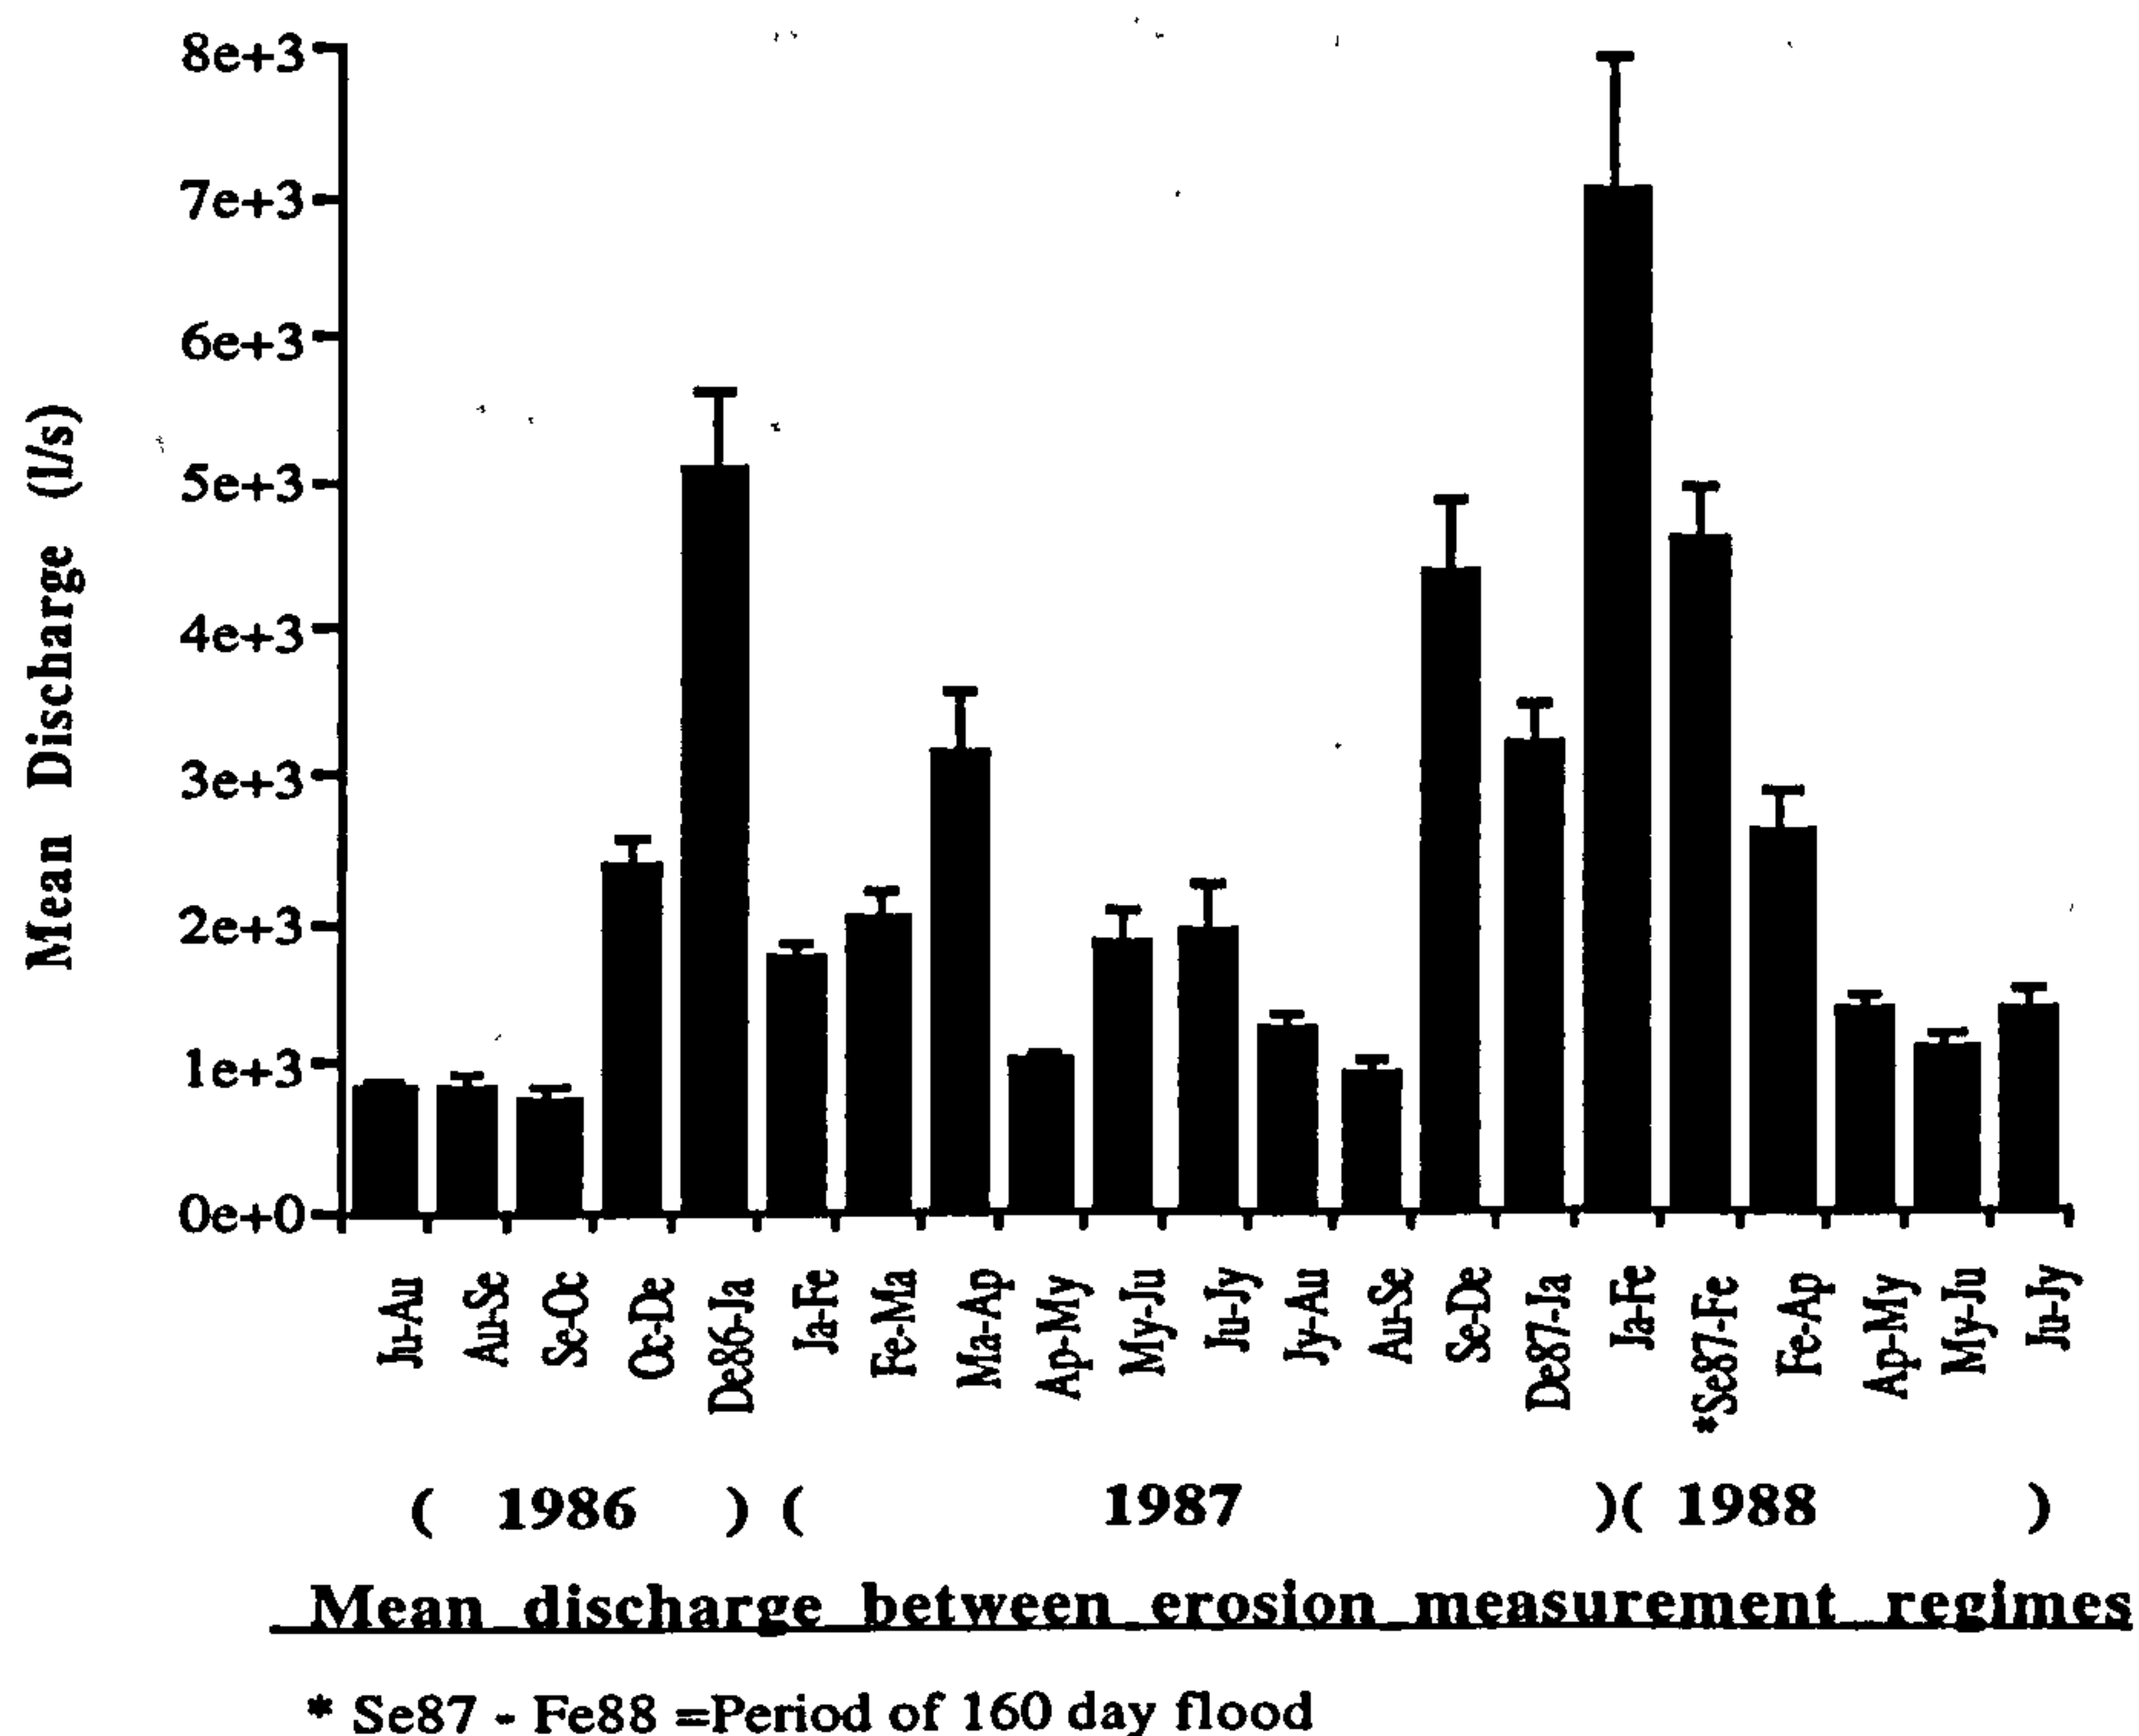
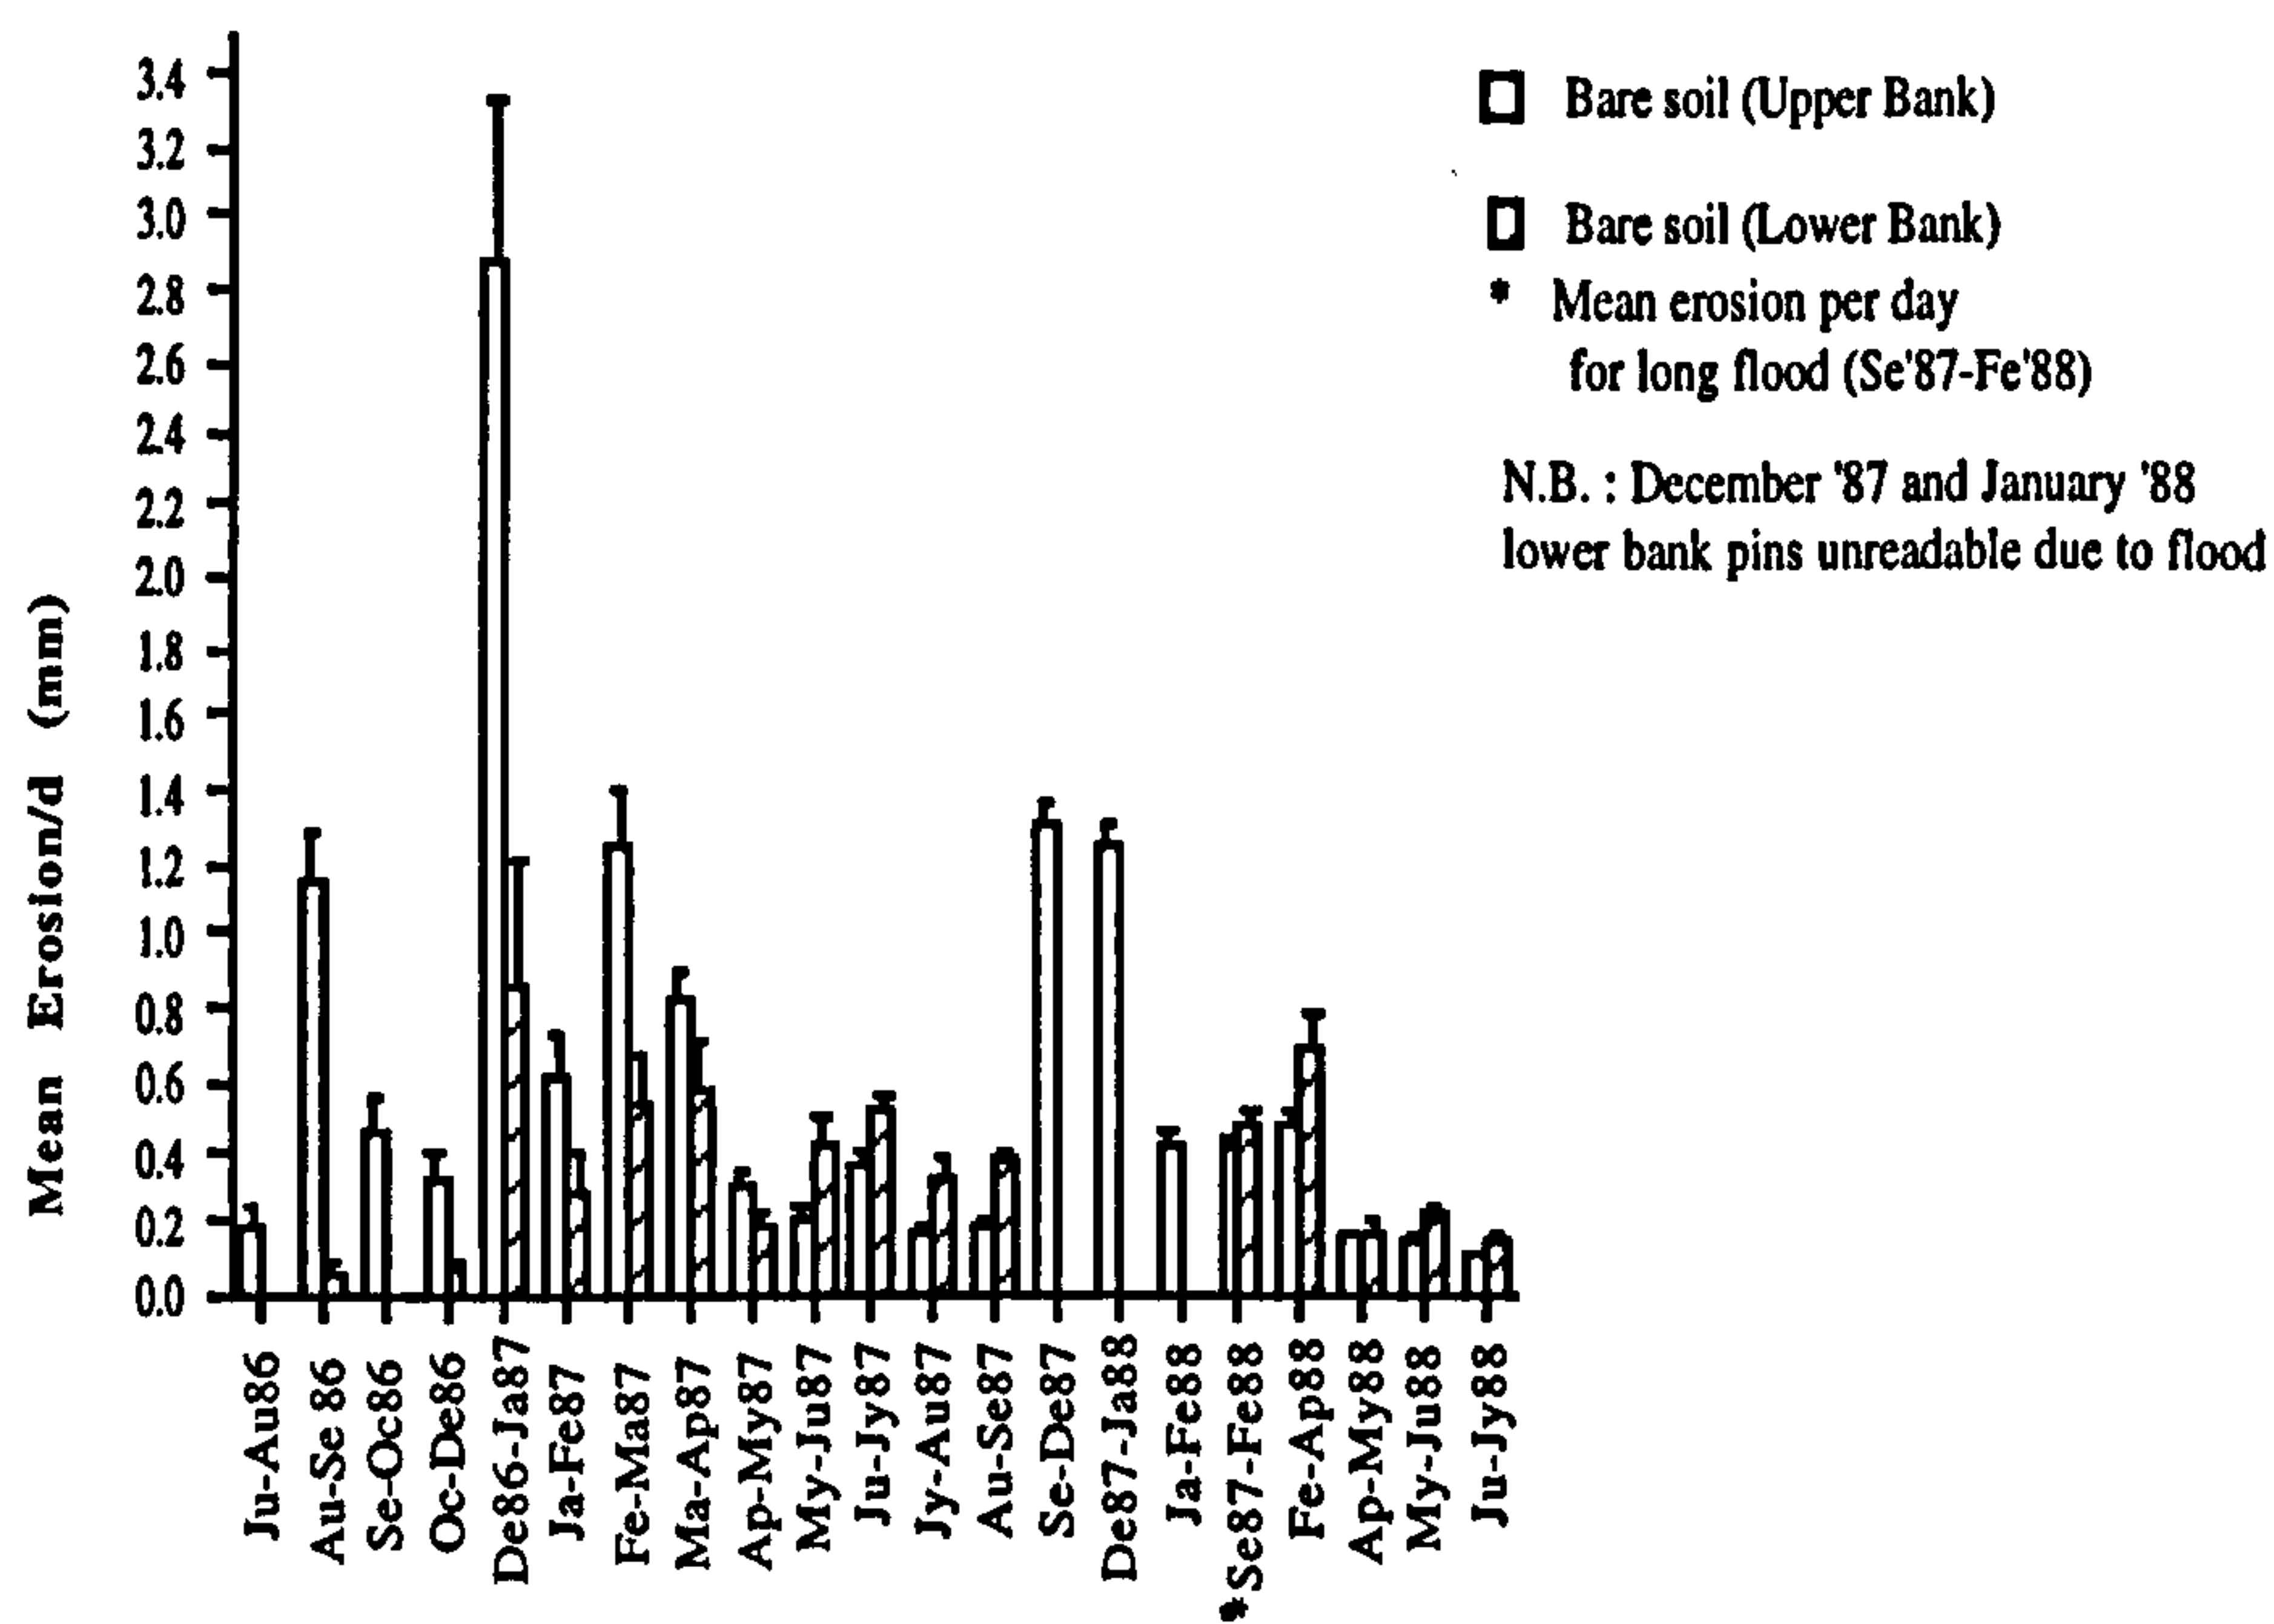
Fig. 3.5. : Comparison of Erosion within Bare Banks (Upper Bank Vs. Lower Bank)

Phase 1 (June 1986 to December 1986): Initial erosion following denudation is much larger in the drier upper region than the wetter lower toe region in the first four months which are characterised by low ambient flow regimes (June to October 1986). While for the upper banks the erosion rates increase to a maximum and then decrease, the lower bank behaves differently. There is hardly any erosion of the toe-region. Debris aggradation from above may have contributed to low erosion measurements in the toe-region as discussed earlier. The first high flow of October to December 1986 did not show an increased rate of erosion. By then the top soil had been eroded. This top soil contained a thick layer of ramified network of dead and decaying roots. As with most plants it is the top soil which contains the highest density of roots (Bohm, 1979). The application of the systemic herbicide possibly created a topsoil which was lower in bulk density. The bank soil exposed, following the erosion of the top soil, for the first high flow was observed to have less dead roots.
